AFRPL-TR-76-95

STORABILITY INVESTIGATIONS OF WATER  
LONG-TERM STORAGE EVALUATION  
THIRD ANNUAL REPORT

AEROJET LIQUID ROCKET COMPANY  
SACRAMENTO, CALIFORNIA

DECEMBER 1976

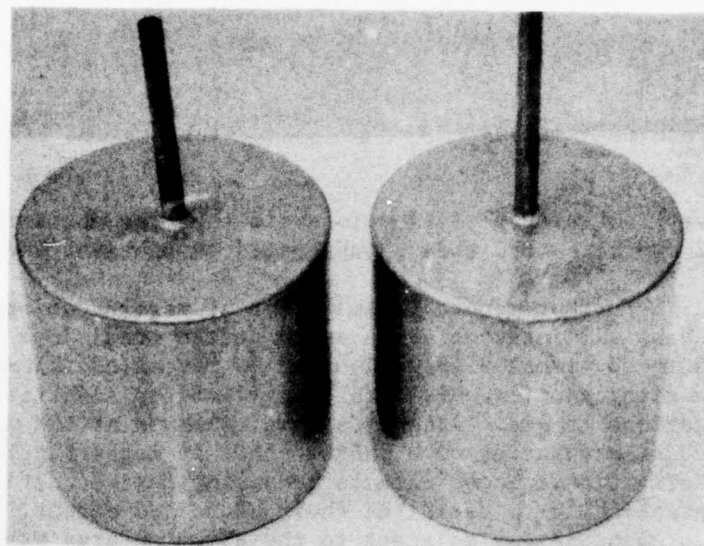
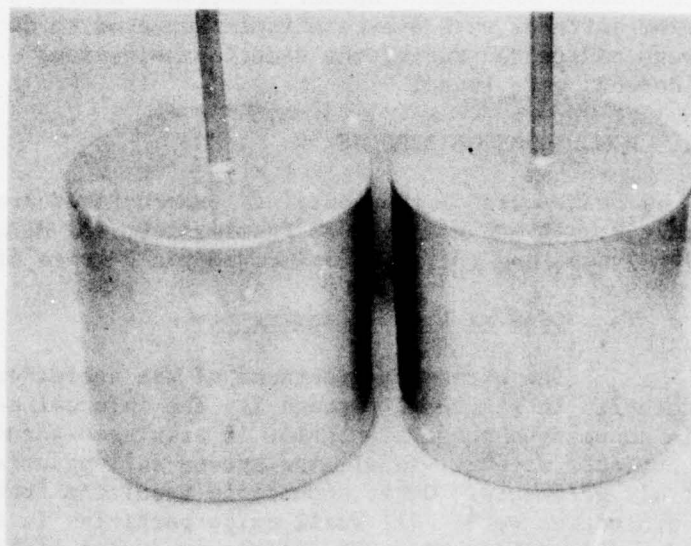
Figure 1. 304 Stainless Steel Containers, Magnification 1/3X

The external appearance of the containers is documented photographically in Figures 1 through 5. The internal appearance of the containers is documented photographically in Figures 6 through 15. Examination of these surfaces without visual aids showed full penetration for the full length of all weldments. Other conditions resulting from fabrication and cleaning procedures were: (1) small oxide particles in the 304 stainless steel welds, (2) etching of A-286 containers during pickling; (3) roughened surface from pickling, a tightly adherent smut, and isolated shiny deposits of material in one of the 17-4 PH stainless steel containers; (4) a tightly adherent smut in the Inconel 718 containers; and (5) isolated areas of titanium oxide and localized circular areas of attack in one of the 6Al-4V titanium containers.

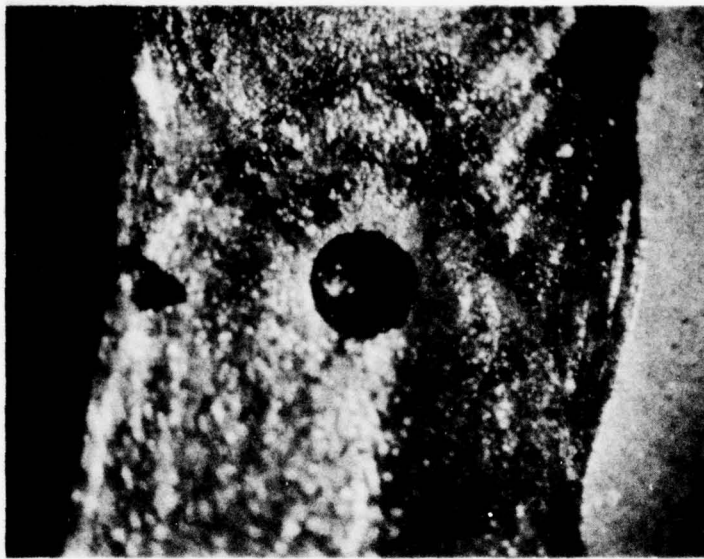
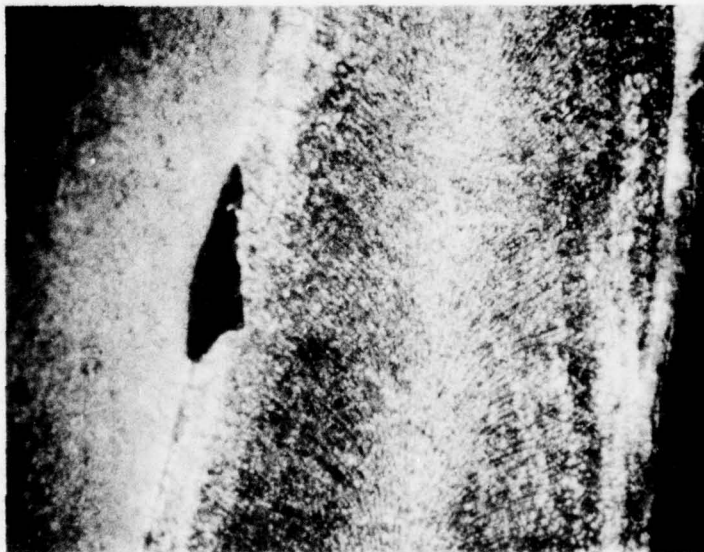
Figure 16. High Temperature Oxide Particles in CRES 304 Containers

The interior of the container exhibited a dull appearance relative to the exterior surfaces of the containers. This condition is attributable to inadequate hydrogen gas coverage in the tank during the annealing process after welding. The oxide particles in the welds were found to be present as in the examination of the six and twelve month exposure tanks and the particles are shown in Figure 16.

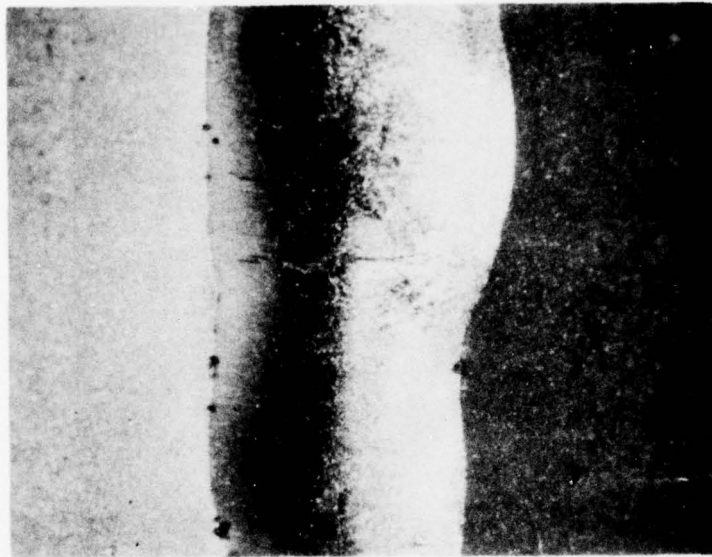
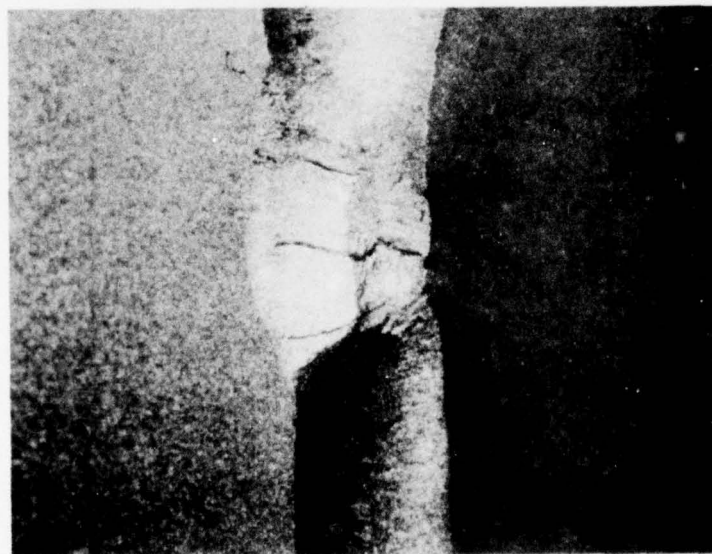
Figure 17. Weld Cracks in A-286 Containers

Three weld shrinkage cracks were found in the containers. Two of the cracks are shown in Figure 17, and they are similar to those found in the tanks which were opened previously. Slight localized etching caused by pickling was found on all the tank interiors. No evidence of corrosion resulting from storage of water could be found.

The presence of contaminants in the titanium alloy containers prior to heat treatment and the weld cracks found in the A-286 and 17-4PH stainless steel containers are attributable to inadequate process control on the part of the container supplier. In spite of the presence of the contaminants, the functional quality of this water was not impaired.

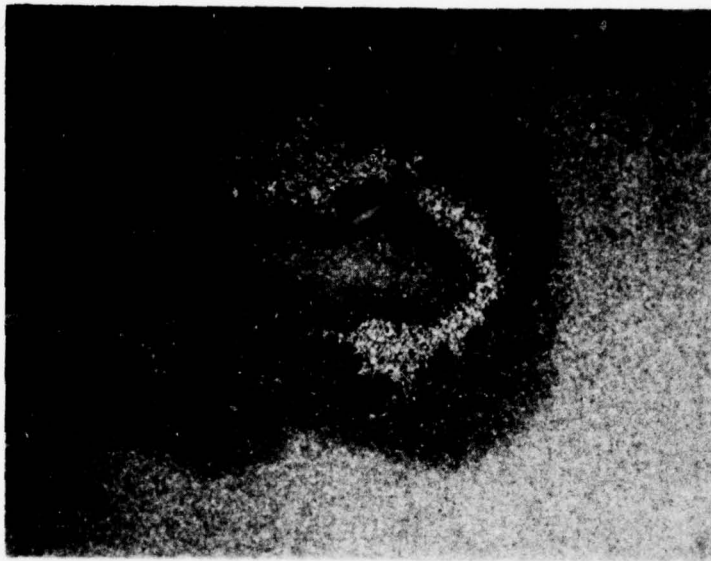
Figure 18. Adherent Metallic Granular Material Found in CRES 17-4 PH Containers

All of the containers exhibited the same condition found in some of the previously examined containers; i.e., localized roughening of the surface due to scale removal during the pickling procedure. The tightly adherent metallic particles found in all previously examined containers and identified as 17-4PH stainless steel was also found in three of the four containers examined during this year. Because this contaminant is identical in appearance to those previously analyzed, a chemical analysis was not performed. The conditions are documented in Figures 18 and 19. Weld cracks were also found in three of the four tanks examined during the current year. A representative photomacrograph and photomicrograph of these cracks is shown in Figure 20. These cracks occurred during welding and are not the result of the storage of water.

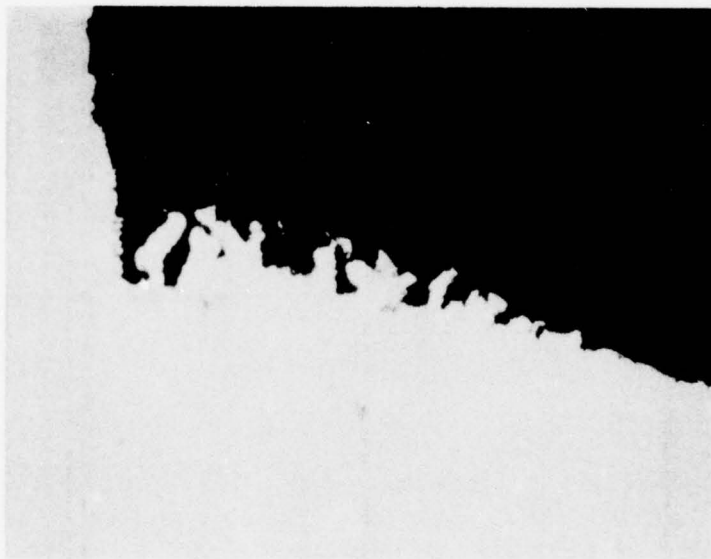
Figure 21. Dark Appearing Edges of Inconel 718 Welds are Voids Produced by Oxide Removal During Pickling

As with the previously examined containers, examination of the interior surfaces at moderate magnification revealed a dark, porous area at the edge of all closure weldments as shown in Figure 21. This condition is caused by selective attack during pickling; the entrapped oxides

present because of inadequate inert-gas coverage during welding are removed by the pickling process. The condition is not attributable to the storage of water. All of the tanks displayed a tightly adherent smut as a result of the pickling procedure.

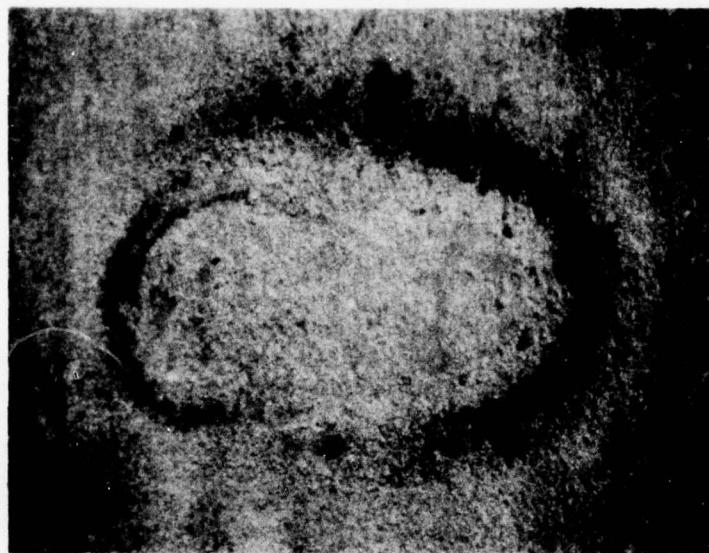
Figure 22. Staining of Titanium 6Al-4V Containers from Inadequate Cleaning Prior to Heat Treatment

All of the containers except one exhibited small isolated areas of titanium oxide in the interiors caused by the heat treatment (aging) and the areas were not removed during the pickling procedure. Examination of mottled areas at low magnifications revealed that these areas are primarily stains. Portions of the stained surfaces contained crater-like areas outlined by knife-life corrosion as shown in Figure 22. Metallographic examination of sections taken through these areas revealed no detectable depth to the corrosion effects associated with the stained areas. This condition is attributed to inadequate cleaning of the container interiors prior to heat treatment. No defects attributable to the storage of water were found.

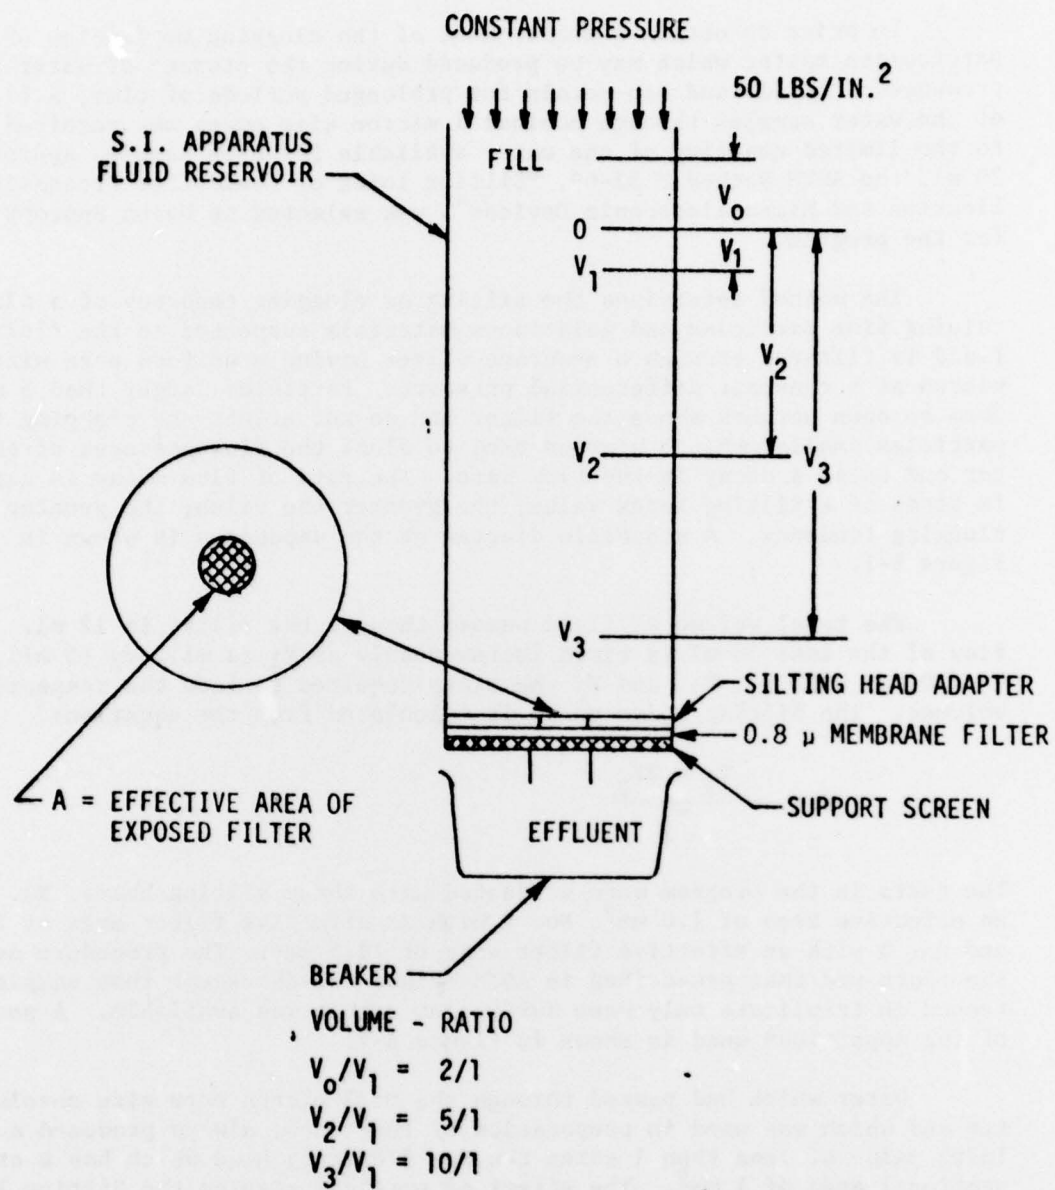
Figure B-1. Schematic of Silting Index Apparatus

The method determines the silting or clogging tendency of a fluid containing fine particles and gelatinous materials suspended in the fluid. The fluid is filtered through a membrane filter having a uniform pore size of 0.8 micron at a constant differential pressure. Particles larger than 5 microns form an open network above the filter and do not affect the clogging tendency; particles smaller than 5 microns tend to block the flow passages of the filter and cause a decay in the flow rate. The rate of flow decay is expressed in terms of a Silting Index value; the greater the value, the greater the clogging tendency. A schematic diagram of the apparatus is shown in Figure B-1.
